SUMMARY OF THE IMPACT OF CONCRETE CRACKING ON

Bridge Decks Constructed with Epoxy-Coated Reinforcing Bars

Iowa Department of Transportation
and Iowa Highway Research Board

Center for Transportation Research
and Education (CTRE) and the
Civil, Construction, and Environmental
Engineering Department at
Iowa State University
Ames, Iowa

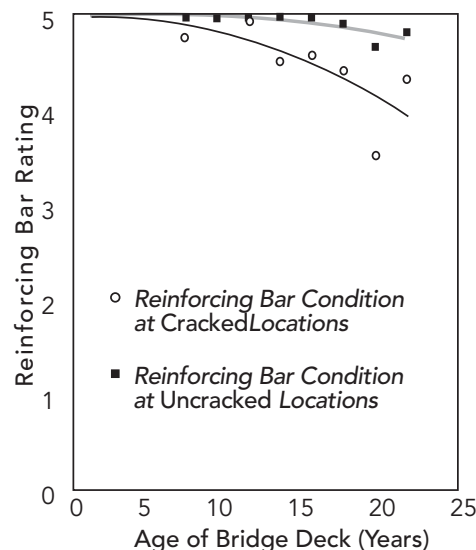
Figure 1

The relationship between the epoxy-coated reinforcing bar rating and the age of the bridge deck has been developed for both cracked and uncracked conditions. A graphical representation of this relationship is shown in Figure 1, along with the

weighted average of data collected from the representative Iowa bridges. These relationships were used to determine the functional service life of the bridge decks reinforced with epoxy-coated reinforcing bars.
