# CRCP in Texas

## Five Decades of Experience

Prepared by:  
The Transtec Group, Inc.  
Austin, TX

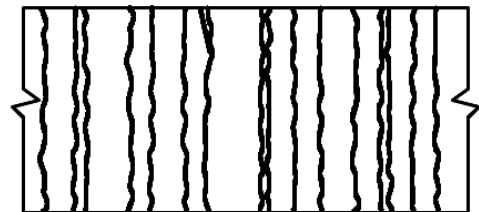
**Figure 1**

**CONTINUOUSLY REINFORCED CONCRETE PAVEMENT WITH TYPICAL TRANSVERSE CRACK PATTERN**

CRCP is a unique concrete pavement in that there are no intermediate transverse contraction or expansion joints built in for crack control, as is the case with jointed concrete pavements. Instead, over time, a series of transverse cracks appear across the pavement width (Figure 1). The transverse cracks do not impair the structural integrity of the pavement.

The cracks occur naturally in the concrete and are somewhat randomly spaced. A crack spacing of 3 to 8 feet apart is desirable.

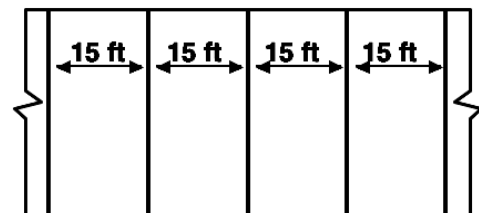
**UNREINFORCED CONCRETE PAVEMENT WITH TRANSVERSE CONTRACTION JOINTS AT 15 FT. SPACING**

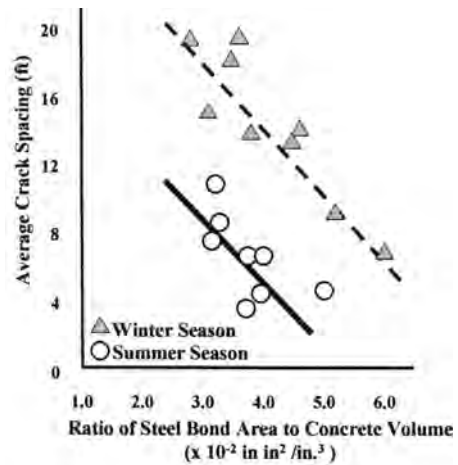
**Figure 2**  
RELATIONSHIP BETWEEN CRACK SPACING, STEEL BOND AREA, AND PLACEMENT SEASON

Using data collected in Texas, Illinois, and Indiana, the TxDOT found that a linear relationship exists between crack spacing and the longitudinal steel bond area (Figure 2). For smaller reinforcing bars, the bond area is larger and the resulting crack spacing is smaller. For larger reinforcing bars, the total bond area decreases and crack spacing increases, assuming the same steel percent. From this analysis, the TxDOT limited bar size to 5/8 inch diameter (#5 bar) to prevent the formation of wide crack spacing.

The TxDOT also found that placement season influences crack spacing. The crack spacing is wider in cold-weather placement than it is for warm-weather placement, i.e., higher temperatures increase the crack frequency. The influence of temperature on cracking was investigated in greater detail in the 1980s and 1990s.

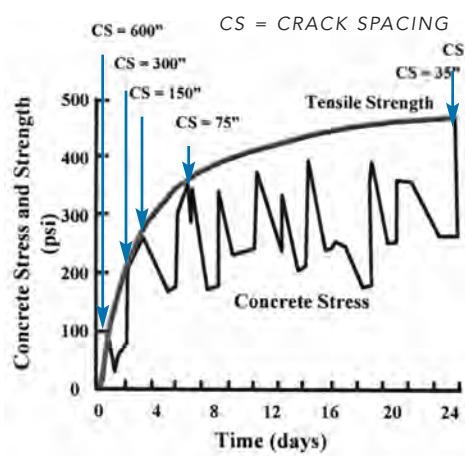
**Figure 3**  
RELATIONSHIP BETWEEN CRACK SPACING AND PAVEMENT AGE

Whenever the concrete stress exceeds the concrete tensile strength, a crack forms. The TxDOT found that crack spacing decreases rapidly during the first 30 days after concrete placement (Figure 3). It is during this period that the concrete has not yet reached a large percentage of its strength.

As shown in Figure 3, the crack spacing is slightly less than 35 inches at 24 days. This relationship also demonstrates the need for uniform concrete strength throughout the section if evenly spaced cracks are to form. Likewise, crack spacing is directly related to concrete strength. Lower concrete strength will translate to reduced crack spacing.

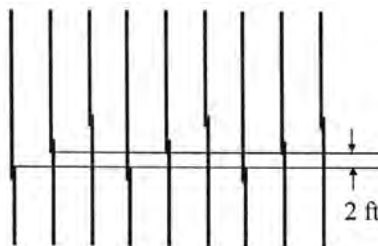
**Figure 4**

### STAGGERED LONGITUDINAL LAPS IN CRCP

Condition surveys taken on the first mile of construction revealed that widened cracks occurred every 40 feet along the pavement. These cracks corresponded to the locations at which reinforcing bars were lapped together.

After these initial observations, the TxDOT chose to stagger each lap relative to the adjacent laps (Figure 4). For subsequent projects, the pavement design details were revised so that [only one-third of the laps could be placed within any two longitudinal feet across the pavement.](#)

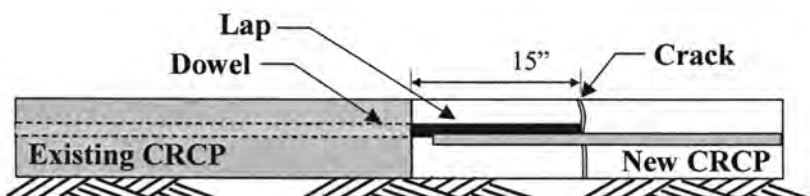
**Figure 5**

### CONSTRUCTION JOINT FAILURE

Construction specifications at the time called for longitudinal reinforcing bars to protrude from the end of the concrete pavement a length of 20 times their diameter—or 15 inches (Figure 5)—at the end of a day's construction. These protruding reinforcing bars would provide a lap for splicing with bars in subsequent construction..

In all cases where construction was not resumed for three or more days, the transverse construction joints failed, with wide cracks seen consistently near

the construction joints. During this three-day break, shrinkage and hydration stresses built up in the curing concrete that caused the free pavement ends to move back and forth longitudinally. Subbase restraint was small, so the longitudinal movement was large.

When construction started up again, the bond between the reinforcing bars and the new, weaker concrete could not sustain the stress from the longitudinal movement of the existing pavement. This resulted in bond slip-page failure, forming wide transverse cracks 15 inches into the new construction (matching up with the end of the protruding bars).

The cracks were wide enough that all load transfer was lost. Failures then developed that required full-width repairs at all those locations as soon as the facility was opened to traffic.

To prevent failures at construction joints on subsequent projects, the TxDOT changed the longitudinal reinforcing bar details at these locations, calling for the [longitudinal reinforcing steel to extend a minimum of four feet into the new pavement with laps being staggered](#).

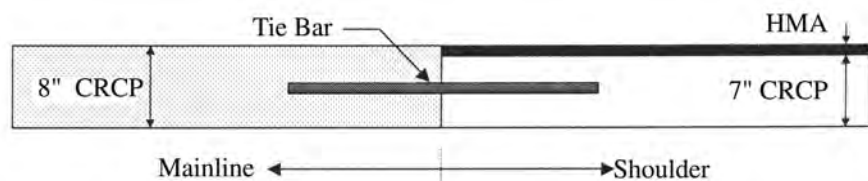
**Figure 6**

#### NEW SHOULDER DESIGN

7-inch-thick CRCP shoulder (with a one-inch-thick asphalt surface for color contrast) was tied into the new 8-inch-thick mainline CRCP ([Figure 6](#)). This solution prevented the formation of failures in the shoulder.

In a 1974 condition survey, another benefit was noted. The stronger CRCP shoulder meant that the CRCP on the mainline was experiencing interior loading instead of edge loading. Pavement stresses were reduced. [The CRCP shoulders substantially increased the pavement life and performance](#).

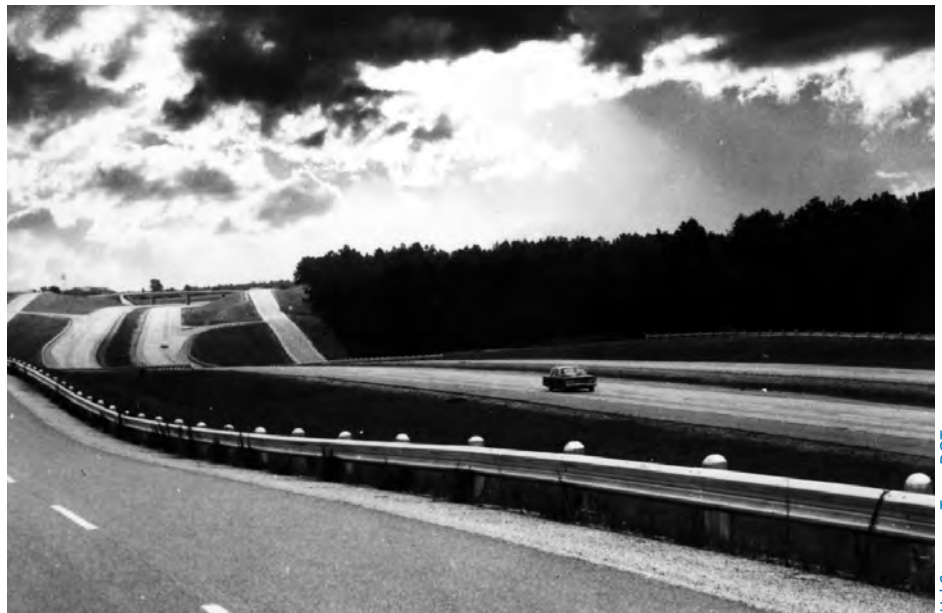
Interstate 45 south of the City of Huntsville

Grade 60 reinforcing bars were used for the longitudinal reinforcing. To study the effects of reducing the amount of steel, the strength of the concrete was reduced from a 5-sack cement mix to a 4.5-sack mix. Strain gages were placed on the longitudinal reinforcing bars and within the concrete. The TxDOT made the following conclusions from these test sections.

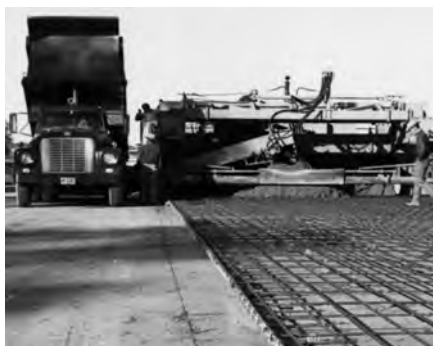
## Case Study No. 6: Jefferson County, Interstate 10

The 8-inch-thick CRCP on I-10 south of Beaumont was placed over 6 inches of stabilized sand shell and 6 inches of sand/clay subgrade stabilized with lime. [A slipform paver \(left\) was first used in Texas to construct the pavement on I-10 and was found to adapt well to CRCP construction.](#)

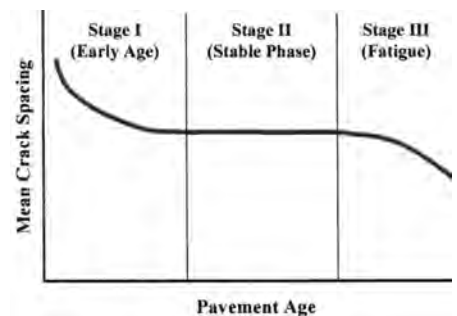
**Figure 7**

#### STAGES OF CRCP CRACK SPACING

The effect of pavement age, traffic loading, and fatigue on crack spacing in CRCP was first recognized in the 1970s. This relationship is shown in [Figure 7](#). During Stage I (about the first three months after placement) concrete cracks due to environmental and internal stresses. During Stage II (20 to 30 years), the pavement stabilizes and the longitudinal reinforcing steel keeps the cracks tight. During Stage III, the pavement begins to fail as more cracks develop due to fatigue and repetitive traffic-induced stresses.

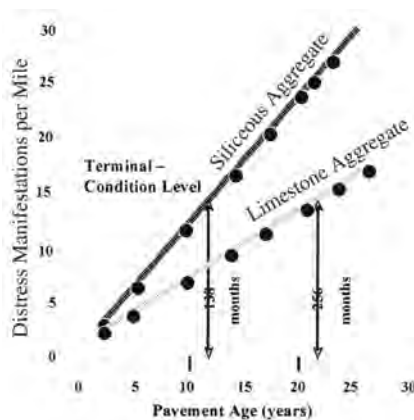
**Figure 8**

### INFLUENCE OF AGGREGATE TYPE ON CRCP PERFORMANCE

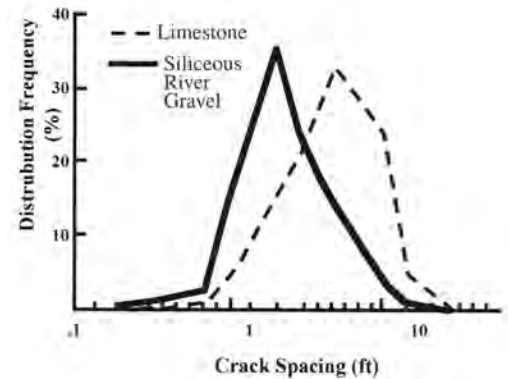
**Figure 9**

### INFLUENCE OF AGGREGATE TYPE ON CRACK SPACING

These differences are due to the influence of coarse aggregate type on crack spacing (Figure 9). CRCP constructed with siliceous river gravel had crack spacing that stabilized at 2 to 3 feet, while CRCP constructed with limestone had crack spacing that averaged 6 feet. Shorter crack spacing tends to lead to increased punchout failures and reduced pavement life in Texas.

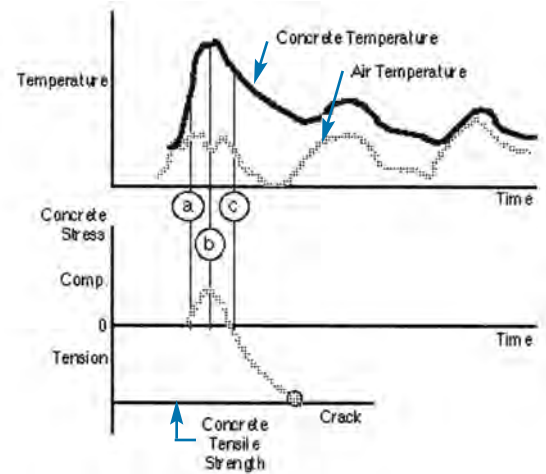
**Figure 10**

#### RELATIONSHIP BETWEEN TEMPERATURE AND CONCRETE CRACKING

The relationship between temperature and concrete cracking is shown in Figure 10. After the concrete sets (point "a" in Figure 10), the concrete goes into compression as the temperature continues to increase. When the concrete temperature starts to decrease, the stresses (point "c") transition from compression to tension. At the point when the tensile stresses exceed the tensile strength, the concrete will crack.
