# Service Life Extension of Northern **Bridge Decks** containing Epoxy-Coated Reinforcing Bars

**Prepared by:**

Wiss, Janney, Elstner Associates, Inc.  
330 Pfingsten Road  
Northbrook, Illinois 60062

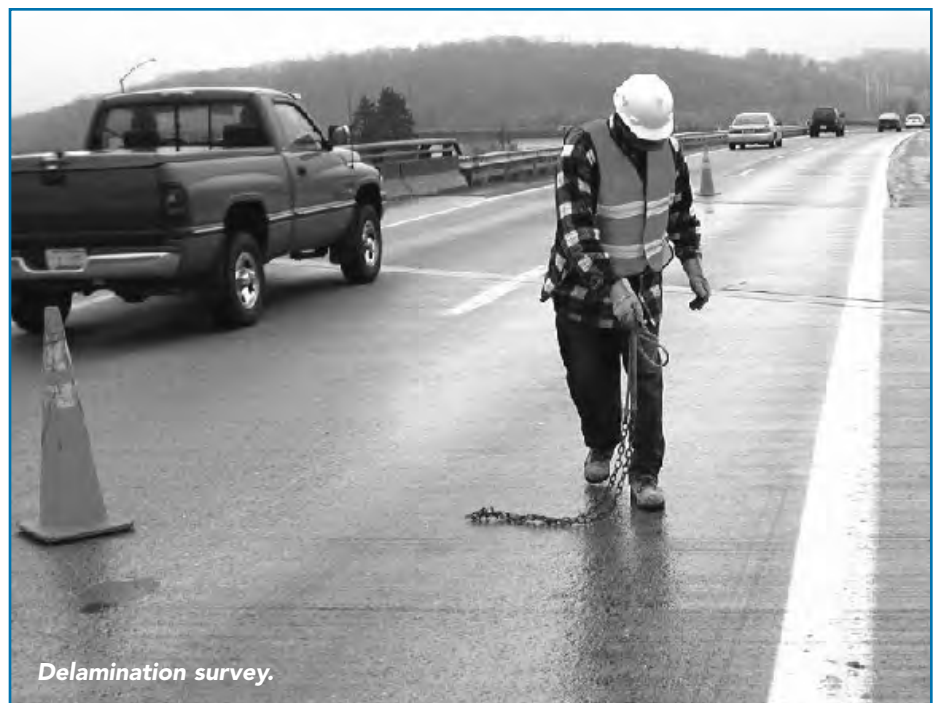
**At right: Delamination survey using chain dragging methods.**

*Delamination survey.*

The first item in the overall condition assessment was a detailed visual examination and delamination survey performed on each bridge deck. (photo below) The damage level of each deck was calculated as the ratio of the total damaged surface area located in the inspected deck area (including spalls and delaminations) to the total surface area inspected. The crack density (ft/ft<sup>2</sup>) was calculated by dividing the measured total length of the identified cracks by the total surface area.

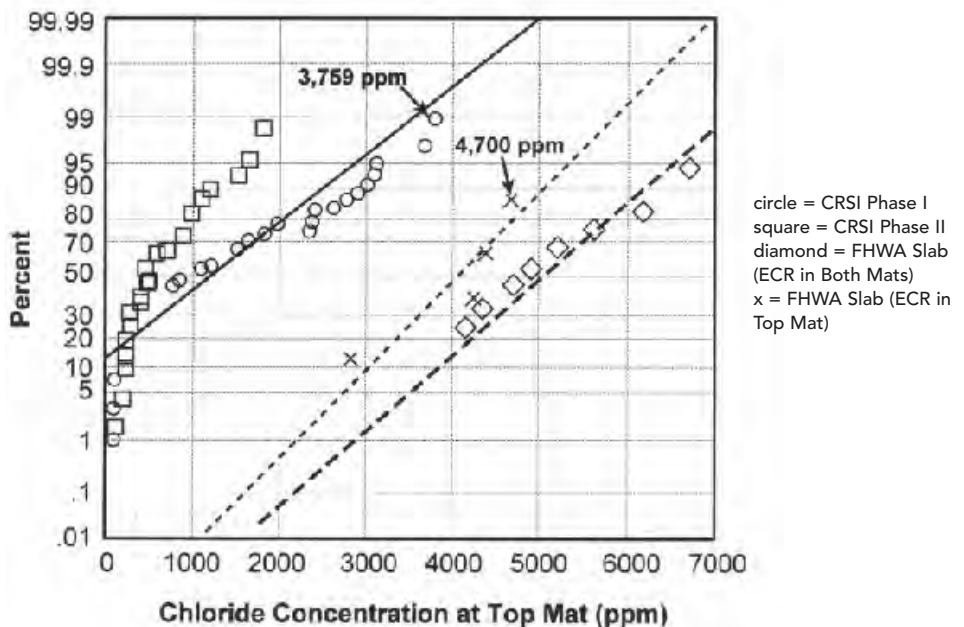
**Figure 2**

Figure 2 shows a compilation of measured chloride concentration for the bridge decks analyzed in this study, along with data from a long-term laboratory study for FHWA that had an epoxy reinforcing bar rating of 1 (no corrosion) and having low corrosion current densities ( $< 0.2 \mu\text{A}/\text{cm}^2$ ). Because the FHWA slabs were exposed to a 96-week Southern Exposure regime (cyclic wetting with 15 percent NaCl solution prior to 5 years of natural weathering), the chloride concentrations were much higher than the ones found for this study.

### CHLORIDE CONCENTRATIONS OF BRIDGE DECKS IN STUDY

Based on the chloride data analysis, a chloride concentration of 1,185 ppm (the mean value of  $C_{th}$  from the

data set) was considered a representative  $C_{th}$  of epoxy-coated reinforcing bars in bridge decks with coated bars in the top mat only. However, it was not possible, based on the data available, to derive a statistically significant value of  $C_{th}$  for epoxy-coat-

ed reinforcing bars in bridge decks with coated bars in both mats. Instead, the maximum observed value of  $C_{th}$  (3,750 ppm) observed without visible corrosion in the top-mat-only data was chosen as the value.

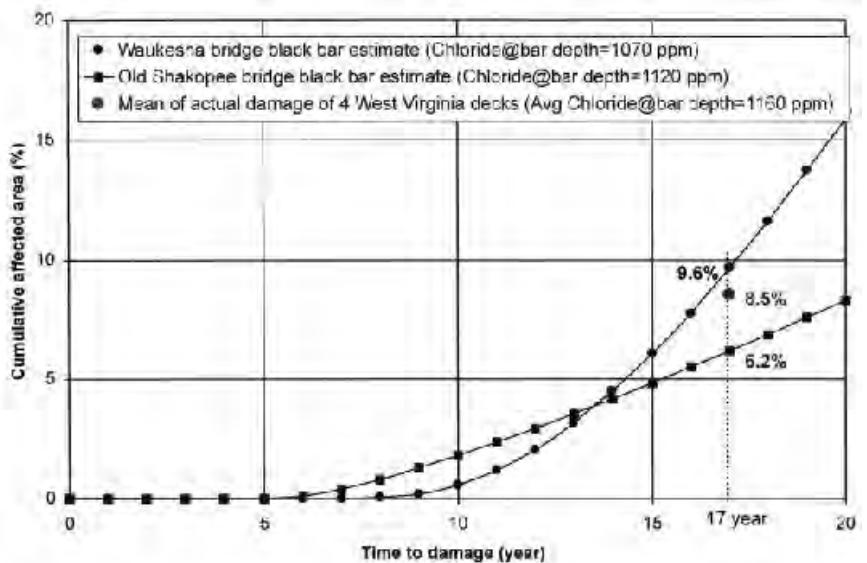
Figure 4

COMPARISON OF MODELED AND FIELD DATA

For purposes of model validation, the model results for uncoated bar cases from two bridge decks (Waukesha, Wisconsin and Old Shakopee, Bloomington, Minnesota) were compared against the West Virginia data. Good agreement between the modeled and field data was found (as shown in Figure 4).

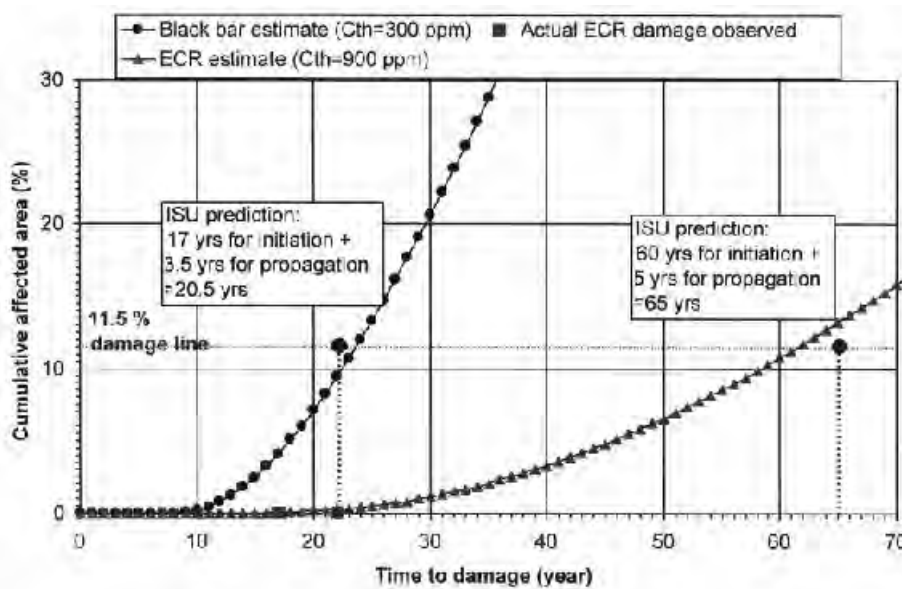
**Figure 5**

For comparison purposes, the bridge deck from Botetourt County, Virginia, was selected for modeling because it had similar mean depth of cover and was projected to have comparable damage to uncoated bars. Using chloride threshold values assumed by ISU (900 ppm for epoxy-coated reinforcing bars and 300 ppm for uncoated bars), the Botetourt County bridge deck was modeled; results are shown in Figure 5.

### BOTETOURT BRIDGE PERFORMANCE COMPARED TO PREDICTIONS

Both comparisons demonstrate that the service life prediction model can produce reasonably accurate service life predictions compared to actual deck performance.

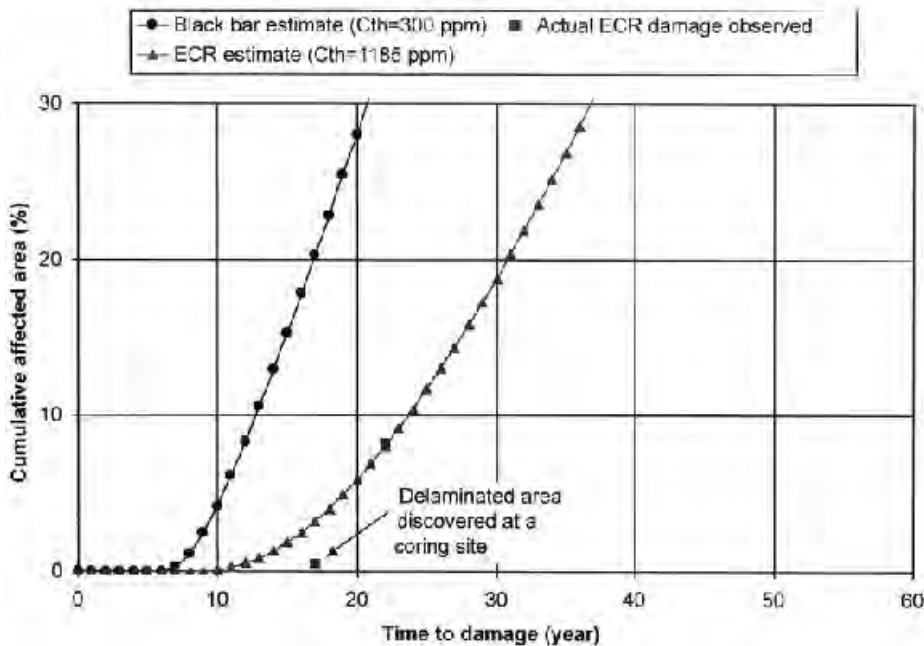
Figure 6

The bridge deck in Blacksburg, Virginia, exhibited the worst physical damage (8.2 percent of the surface area of the deck contained spalls and delaminations) among the decks investigated in this study.

As shown in Figure 6, the prediction model indicates that if uncoated

bars had been used to construct this bridge deck, the deck would have exhibited corrosion damage on about 20 percent of the deck after 22 years in service – well beyond serviceability – compared to the actual damage of 8.2 percent.

## BLACKSBURG DECK PERFORMANCE COMPARED TO PREDICTIONS
